## Sliding window - right-side sliding door pre MY 1985

Numéro d'article	SLI-DOOR-VW-T3-1979
Prix	Le prix commence à partir de 335,00 €
Dimensions	Width: 1082mm Height: 428mm
Convient pour	Volkswagen - Volkswagen T3 Bus

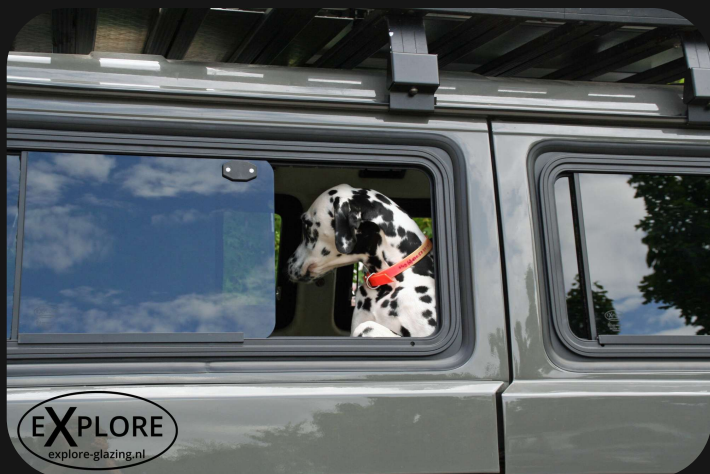
Upgrade your right-side sliding door on the Volkswagen T3 models from 1979 to 1985 with the Explore Glazing sliding window. Experience unparalleled convenience and seamless functionality with this exceptional accessory, equipped with a smooth sliding mechanism that allows for effortless operation and provides you with the opportunity to embrace the invigorating outdoor air.

Equipped with a user-friendly locking mechanism, the Explore Glazing sliding window offers effortless operation and adjustable positions. The glass edges are polished for optimal performance and safety.

Rest assured that our sliding windows meet stringent safety standards, featuring 4 mm toughened safety glass certified by ECE R-43 and DOT, available in privacy grey with a light transmission of 20% (tinted 80%).
